**FANCHER CREEK DAM**

**FRESNO, CALIFORNIA**

**EMBANKMENT CRITERIA  
AND  
PERFORMANCE REPORT**

**JULY 1994**

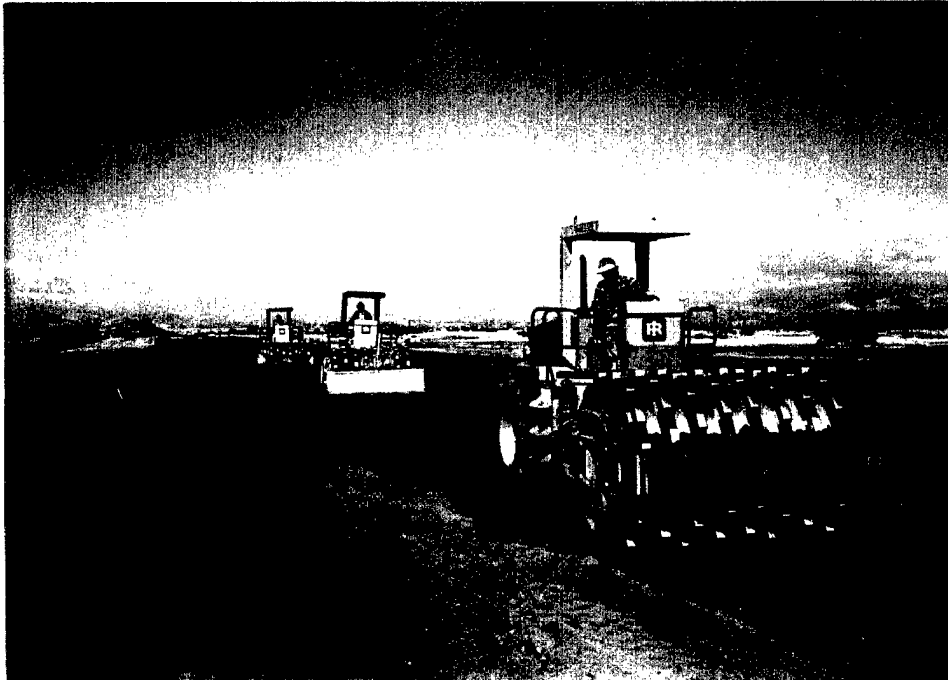
**Photo 18** Towed roller used for compaction in the inspection trench. 8 Oct. 1990

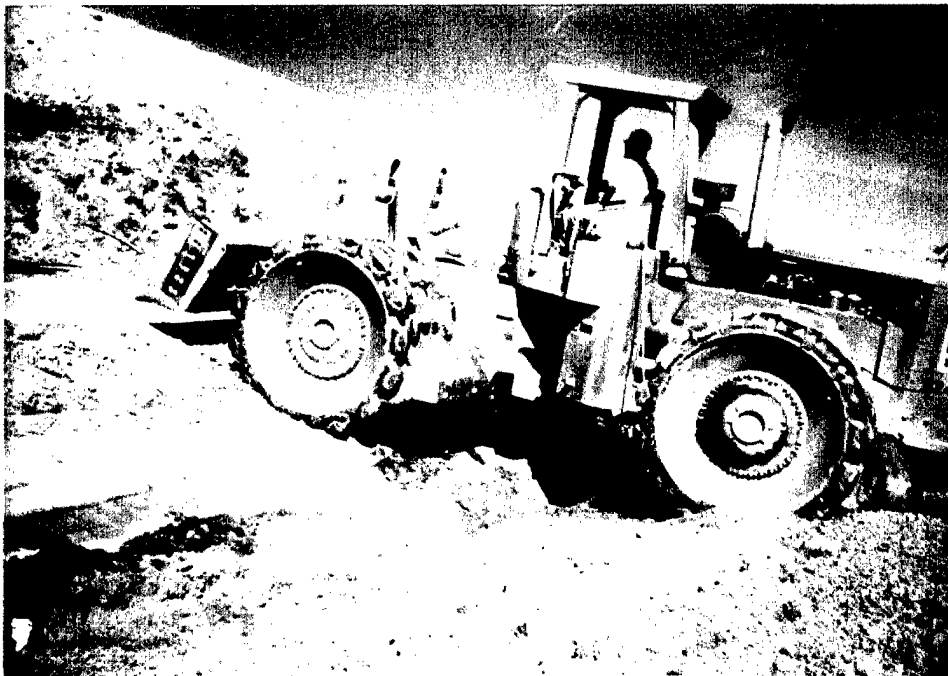
**Photo 19** Dynapac and Ingersoll Rand rollers compacting the embankment. 15 Oct. 1990

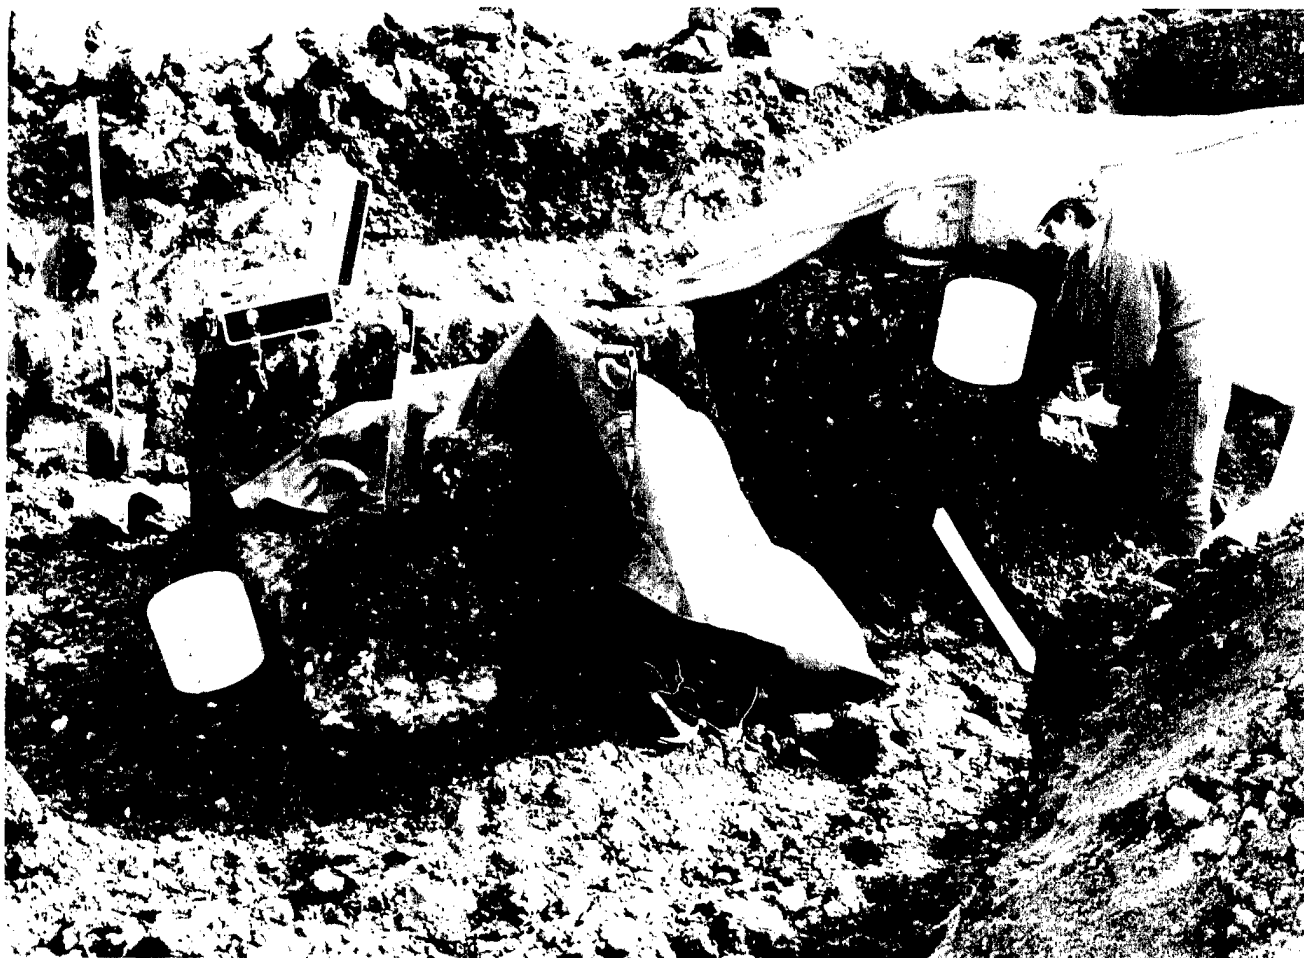
**Photo 21** Early stages of carving undisturbed sample for record sample program. 3 Dec 1990

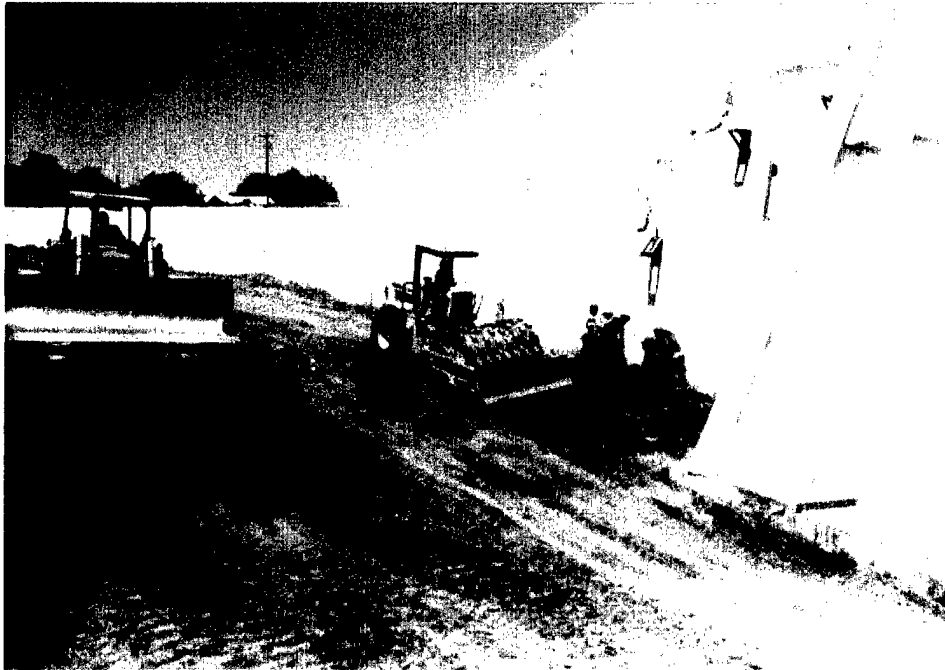
**Photo 25** Embankment material placement on the south side of the spillway.

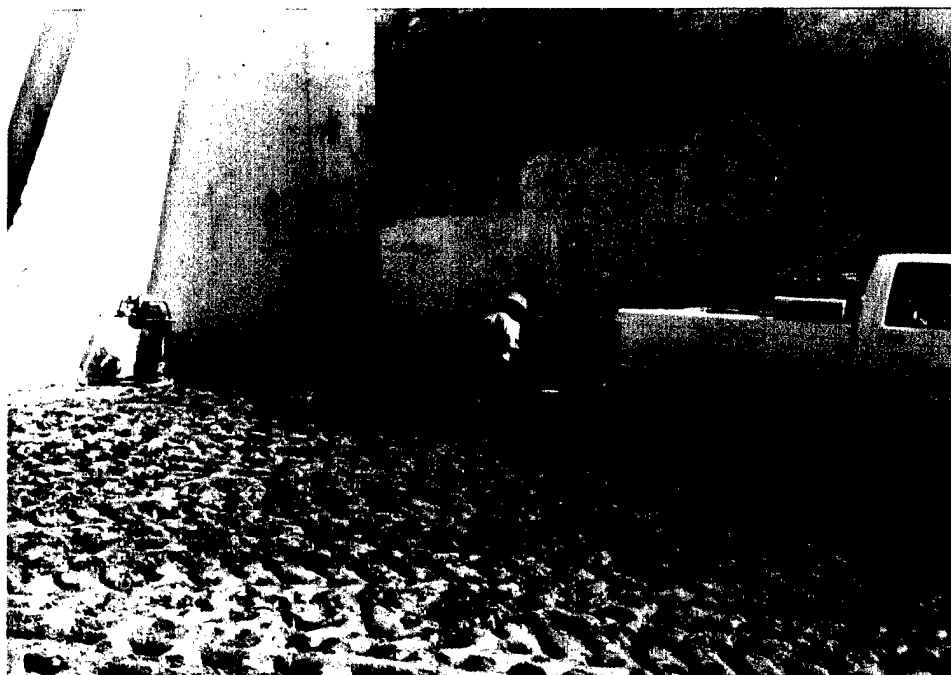
**Photo 27** The random material being compacted between the counterforts.

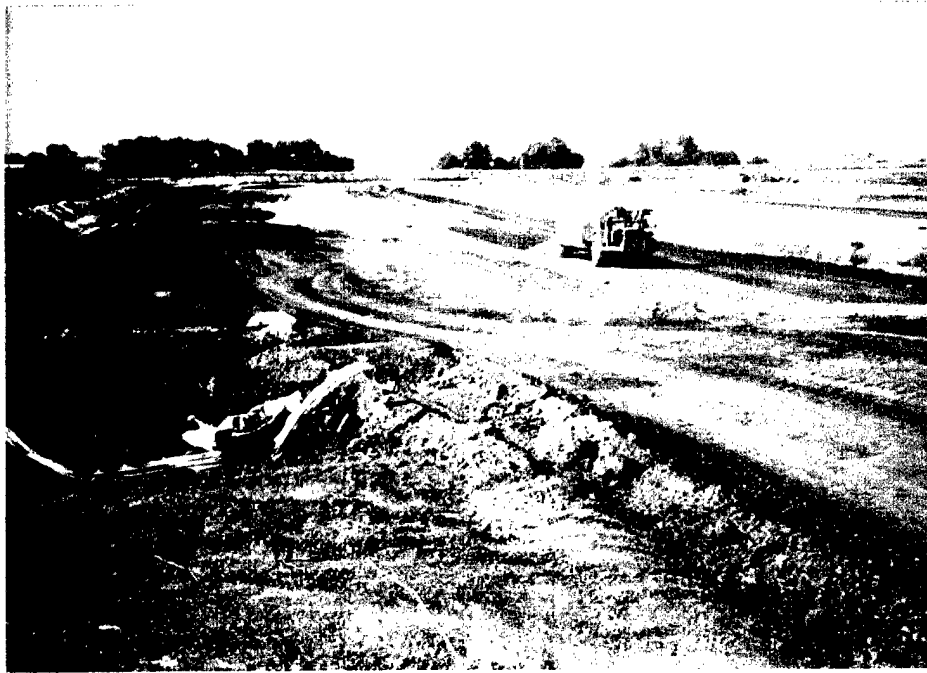
**Photo 29** Aerial view of the outlet works/spillway 14 January 1993.

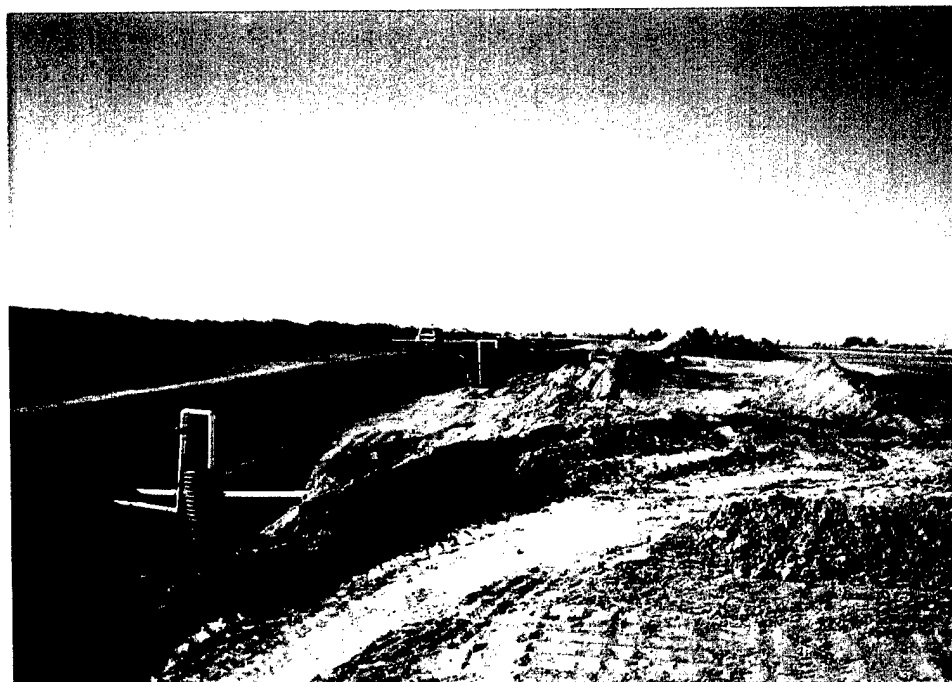
**Photo 5** Dewatering system, showing risers leading into the pipe manifold. 20 Oct. 1990

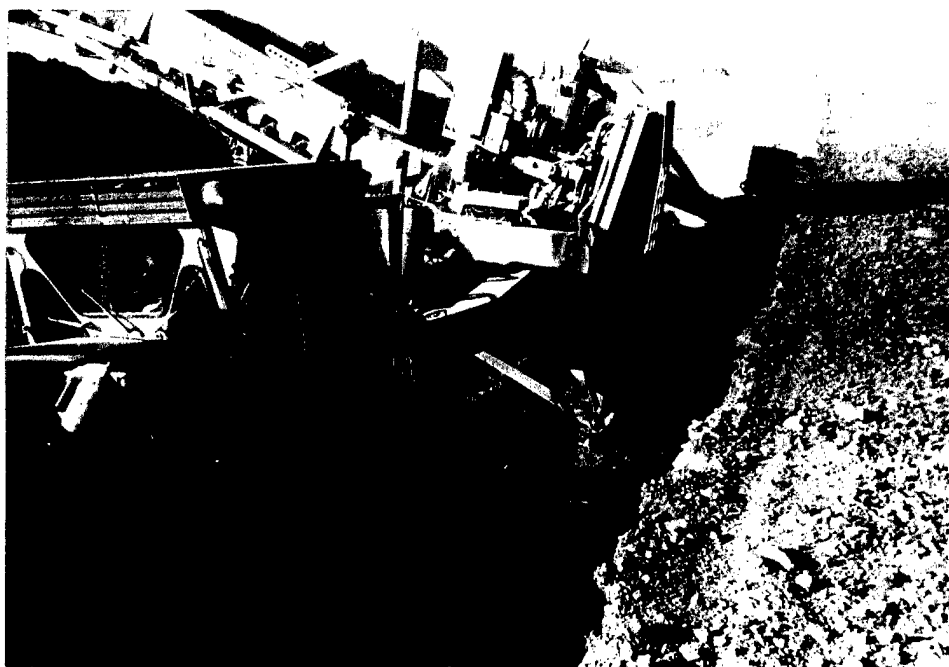
**Photo 11** Holland side cut excavator loading a Holland Wagon. 7 Jan. 1991

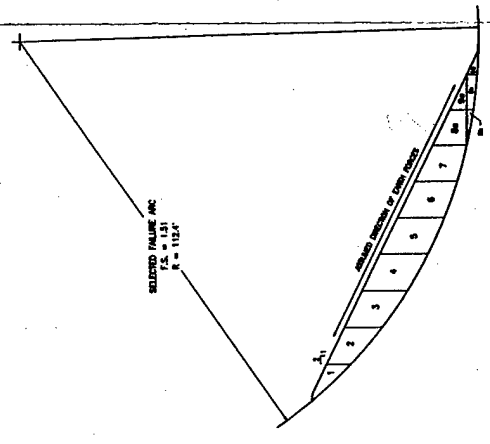
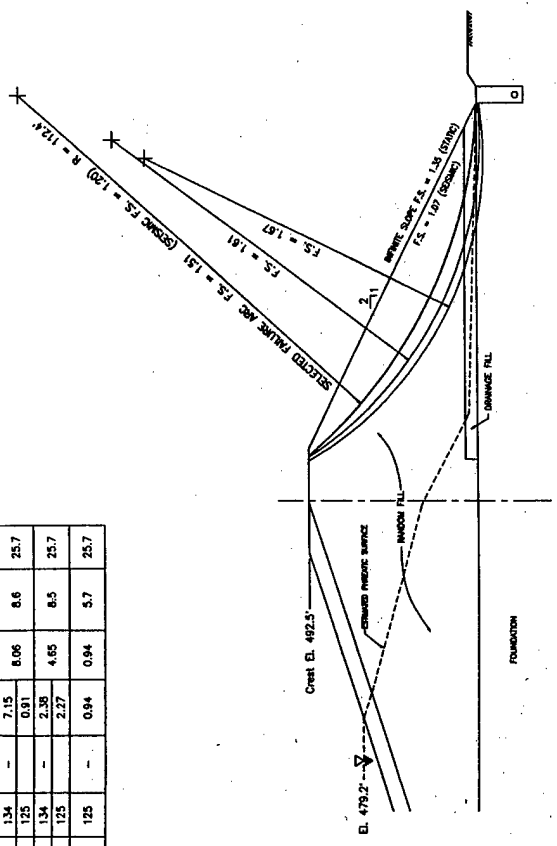
- NOTES
1. Steady Seepage analysis for finite slice method performed by the UTEXAS3 program. Failure arcs shown are considered representative of the more significant portions of the analysis. The results of the analysis are shown to the finite slope condition for both static and seismic conditions.
  2. The computer solution for the Selected Failure Arc shown is a Factor of Safety of 1.51. The manual check of this solution agrees closely.
  3. The seismic condition assumes a horizontal force of 0.10 times the slice weight.

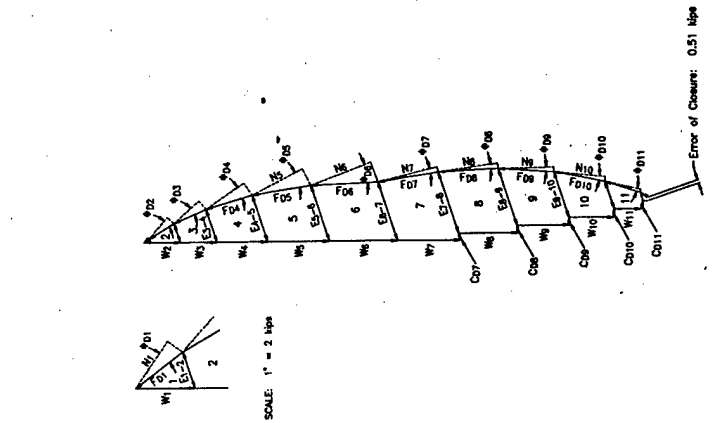
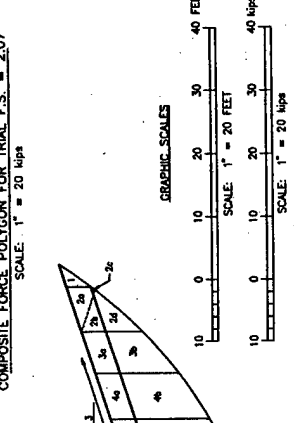
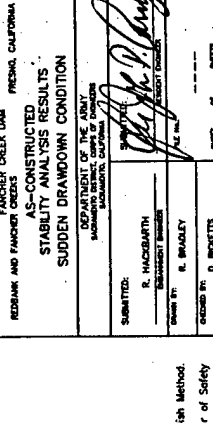
- The Sudden Drawdown analysis was performed using the Modified Swedish Method.
- The computer solution for the Selected Failure Arc shown was a Factor of Safety of 1.20. The manual check of this solution agreed closely.

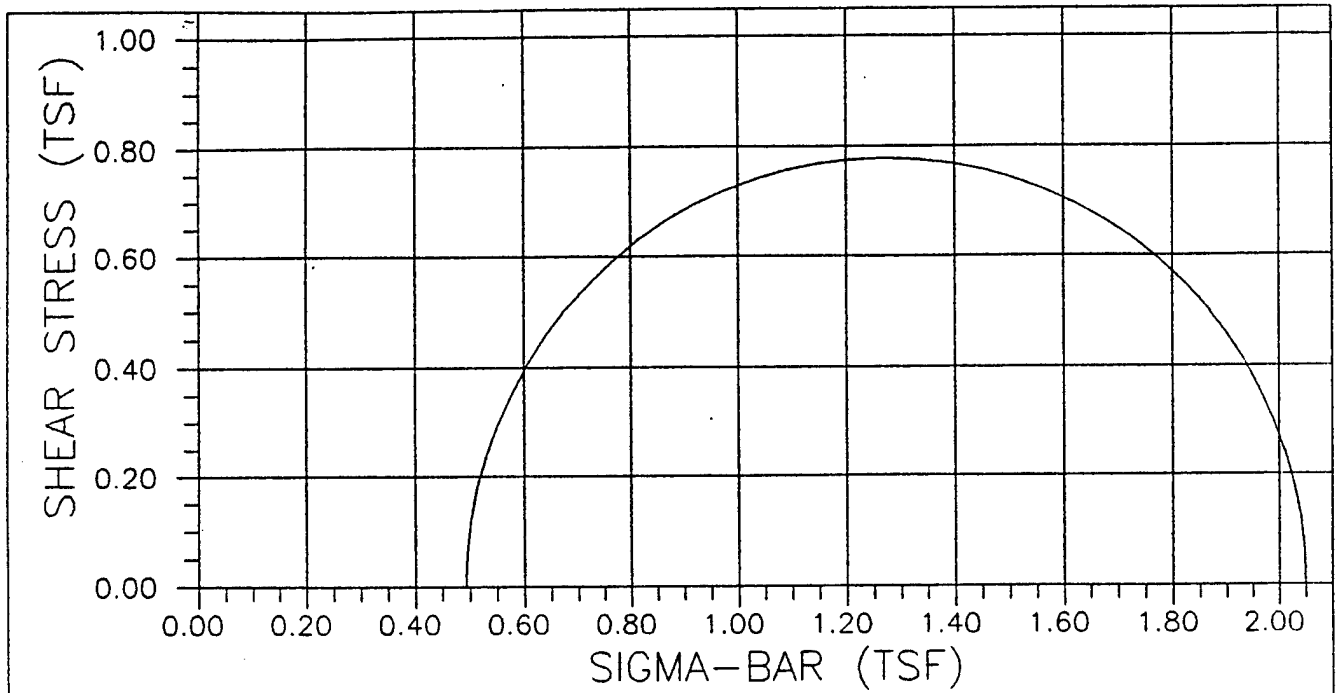
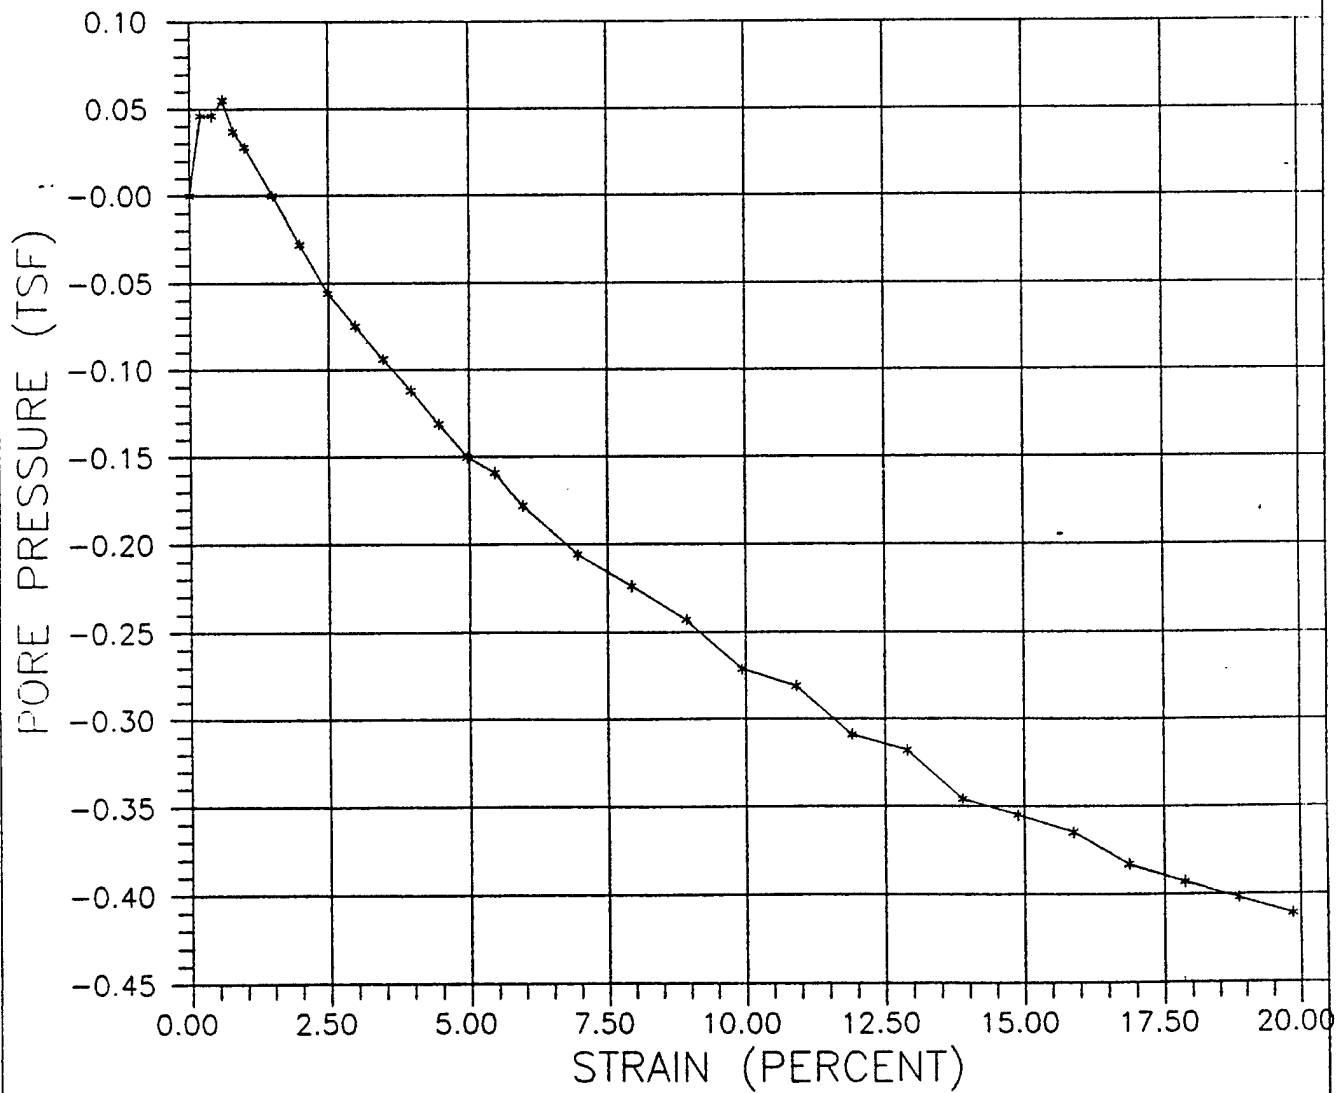
Est.					
LL	PL	PI	$G_s$ 2.70	TYPE OF SPECIMEN	TYPE OF TEST R
REMARKS				PROJECT Fancher Creek Dam	
				BORING NO. 59 + 30	SAMPLE NO. 1
				Elev. 467.78	
				LABORATORY	DATE 2/21/91
TRIAXIAL COMPRESSION TEST REPORT

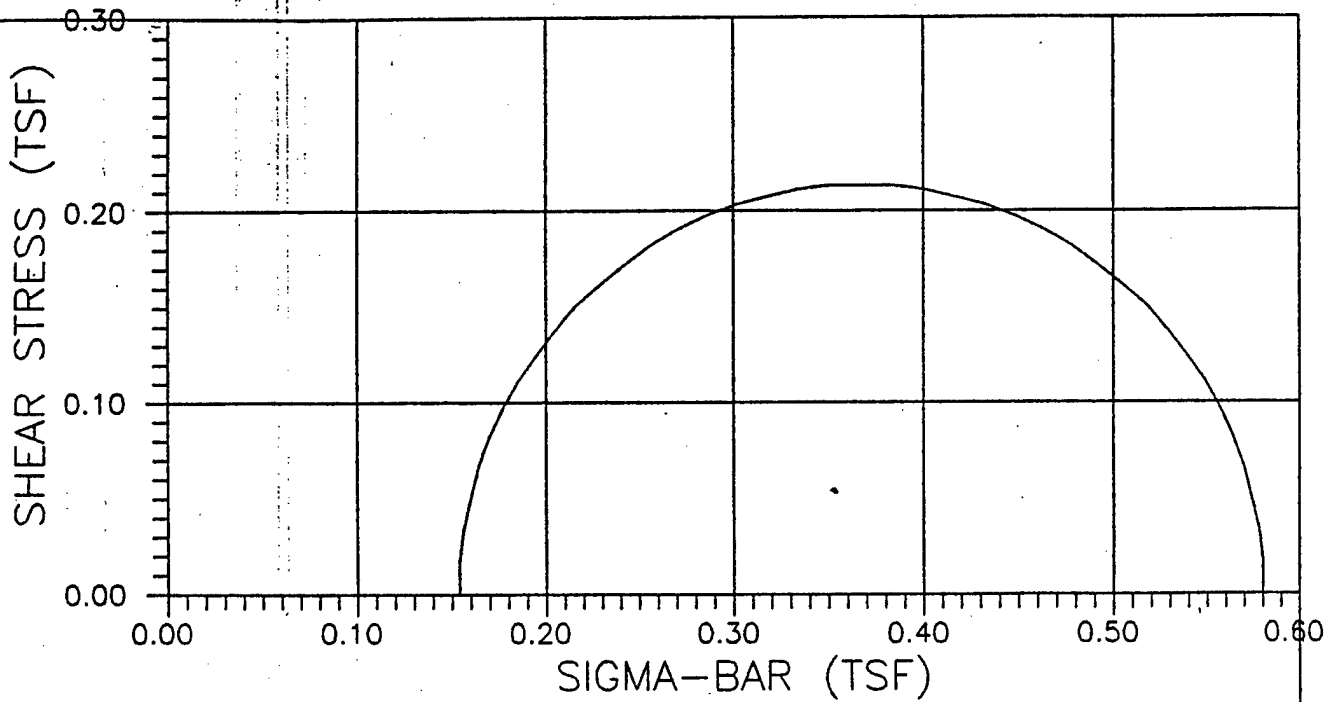
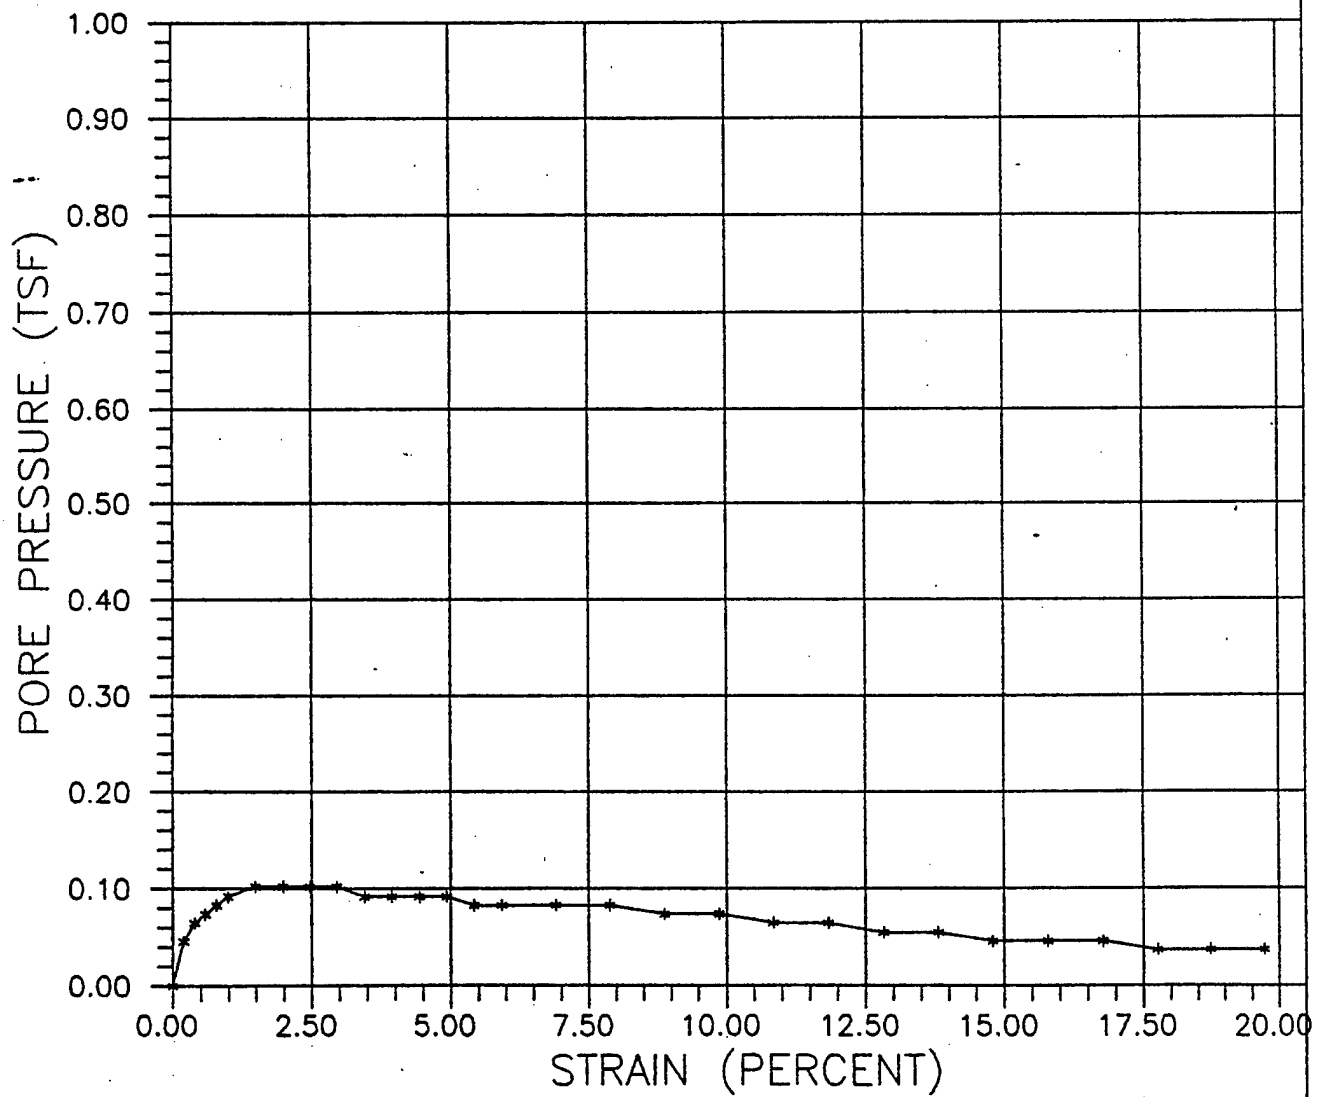
Est.					
LL	PL	PI	$C_s$ 2.70	TYPE OF SPECIMEN	TYPE OF TEST $\bar{R}$
REMARKS				PROJECT Fancher Creek Dam	
				BORING NO. 59 + 30 SAMPLE NO. 2	
				Elev. 467.78'	
				LABORATORY DATE 2/27/91	
TRIAxIAL COMPRESSION TEST REPORT

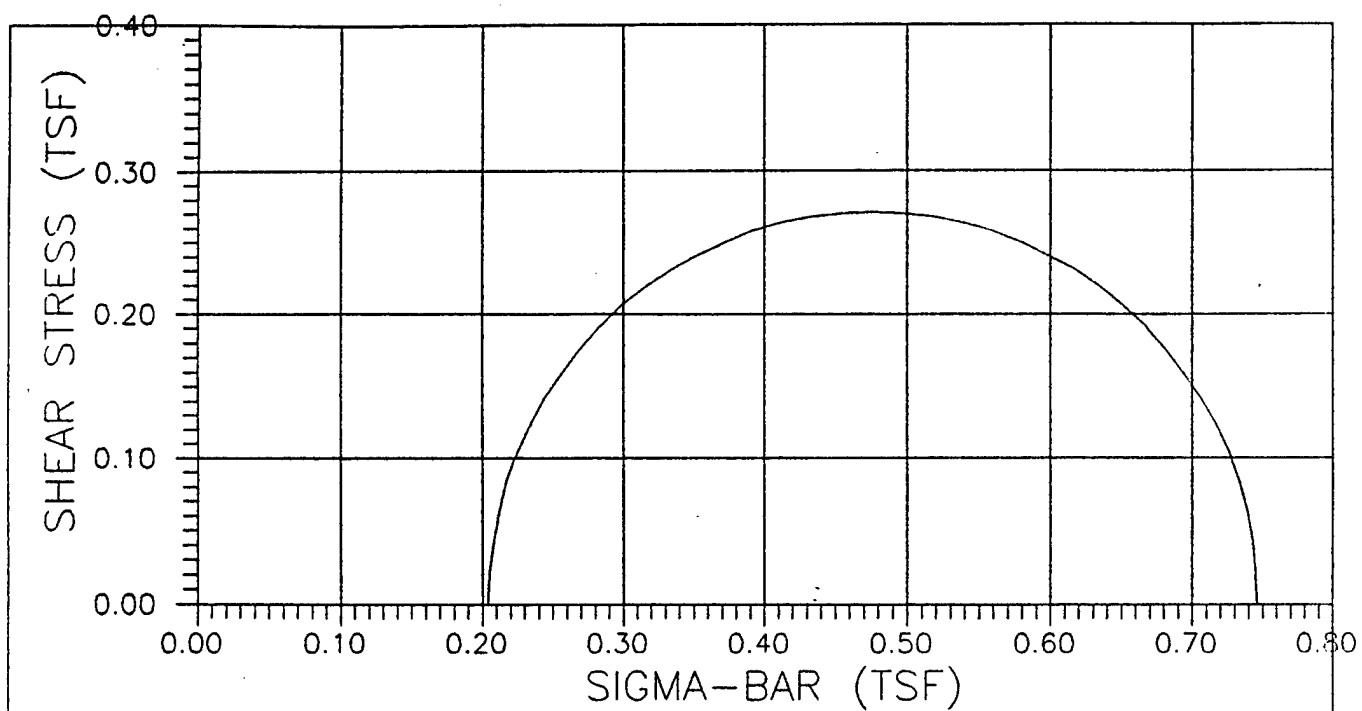
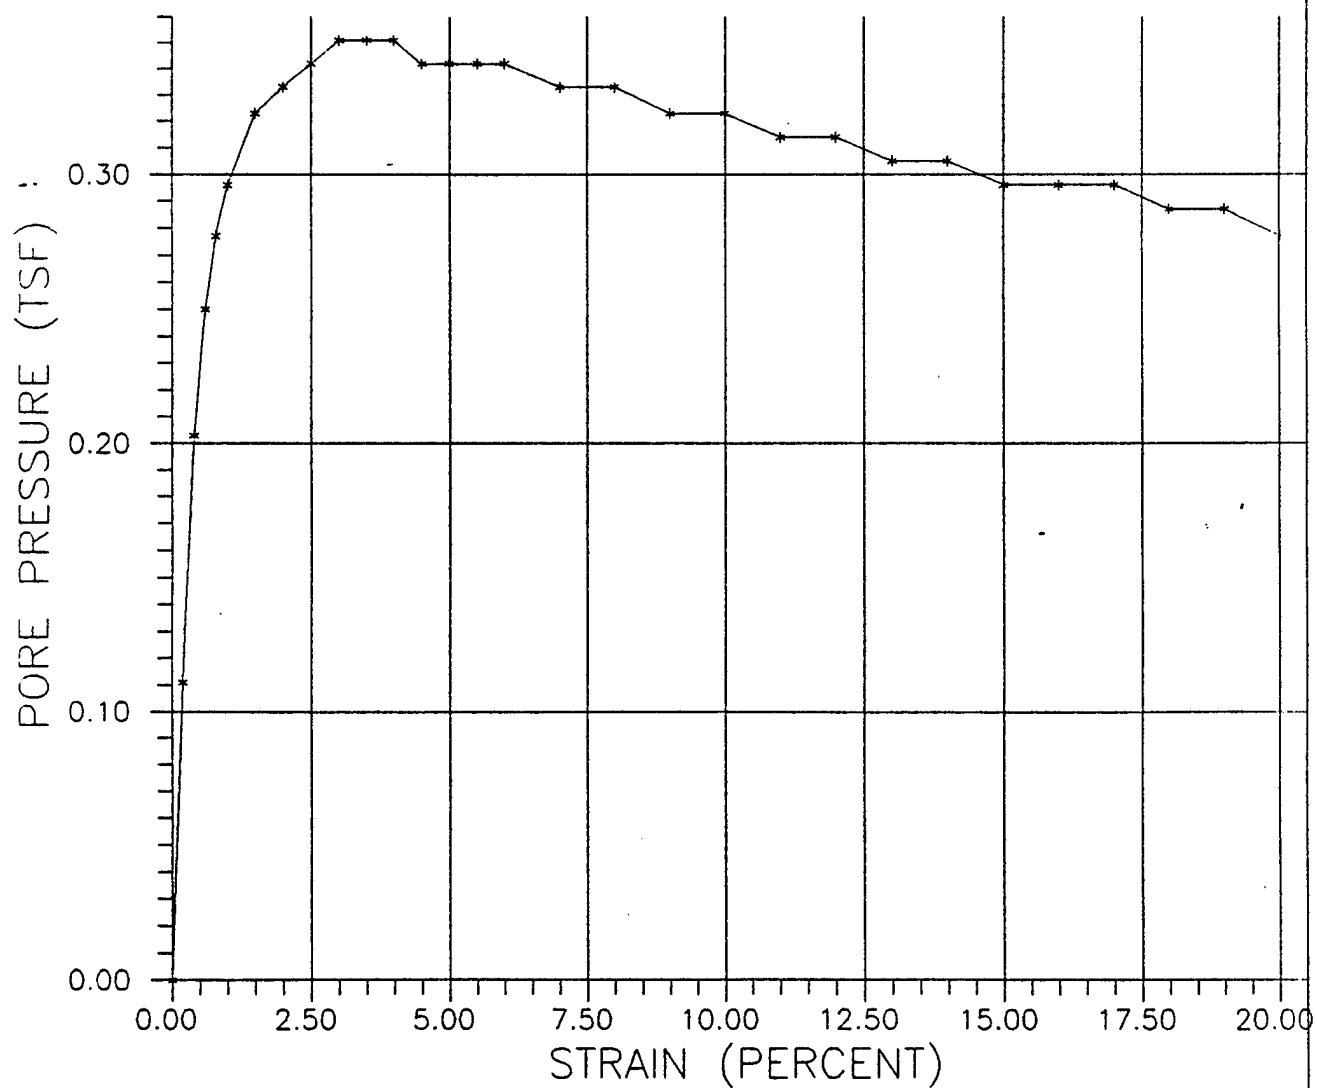
LL	PL	PI	$G_s$ 2.70	TYPE OF SPECIMEN	TYPE OF TEST R
REMARKS				PROJECT Fancher Creek Dam	
				BORING NO. 59 + 30	SAMPLE NO. 3
				Elev. 467.78'	
				LABORATORY	DATE 3/8/91
TRIAXIAL COMPRESSION TEST REPORT
